FINAL REPORT ~ FHWA-OK-20-06

EVALUATING THE PERFORMANCE OF EXISTING REINFORCEMENT FOR OKLAHOMA BRIDGES

Department of Civil, Environmental & Architectural Engineering
The University of Kansas
Lawrence, Kansas

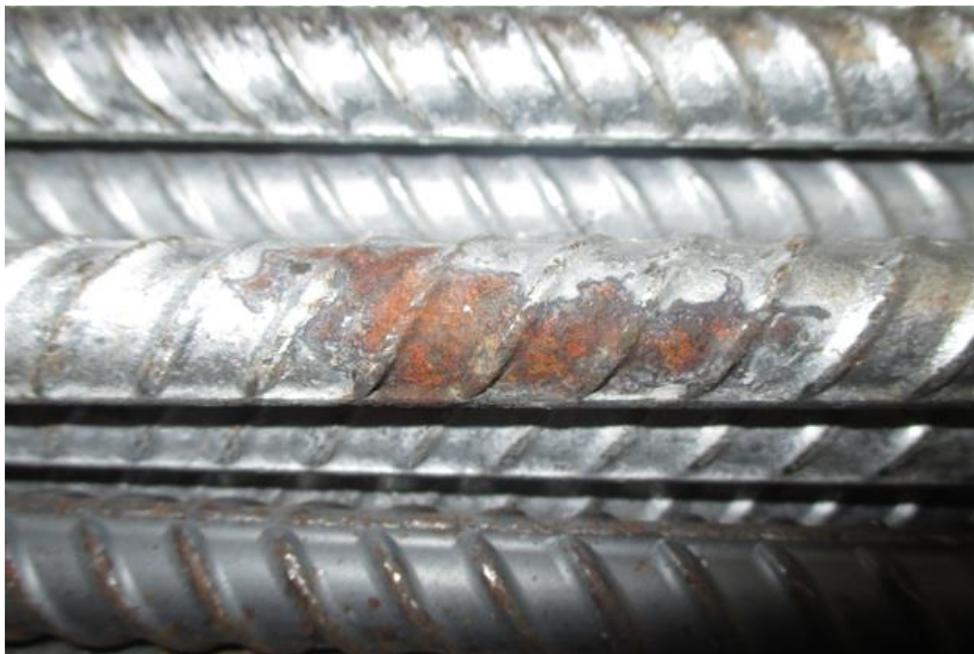
Figure 2.1: Lack of coating and exposed steel on A767 reinforcement. Bars with damaged coatings are not used in tests.

Tests were performed on No. 5 ASTM A775 epoxy-coated reinforcement (ECR), ASTM A767 and A1094 galvanized bars, and ASTM A1035 Type CS bars with 9% chromium. Three heats of ASTM A615 conventional reinforcement were also evaluated. Identified as Conv. A, B, and C, the conventional bars were used to produce the ECR, A767, and A1094 reinforcing bars, respectively. Initial test results led to an expansion of the scope of work to further investigate the effect of UV exposure. As insufficient ECR remained from the original heat of steel, a second heat of epoxy-coated bars (ECR 2) was used for some of these additional macrocell tests. As delivered, some of the A767 bars had limited regions with poor or no coating, and exhibited exposed steel and surface rusting (Figure 2.1); these bars were discarded. The bars were, otherwise, in good condition. The steel chemistry of the bars used in this study is shown in Table 2.1.

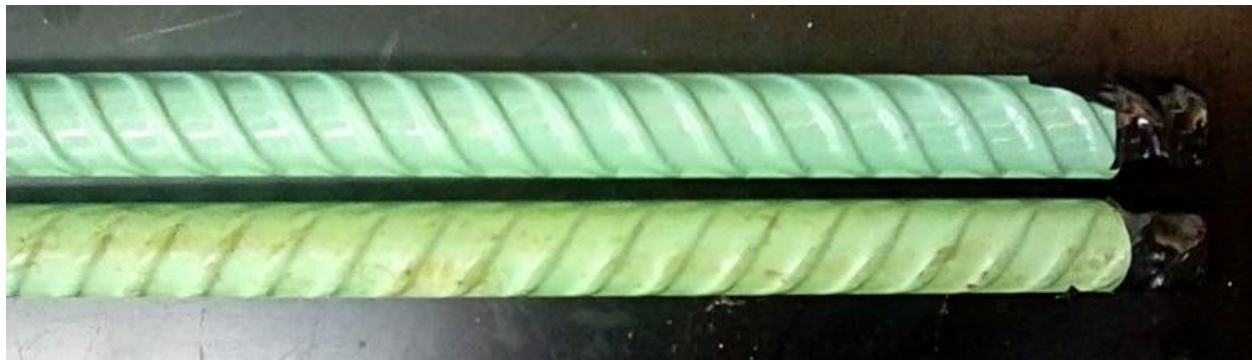
Figure 2.2: ECR before (top) and after (bottom) UV exposure.

Most bars were evaluated in the as-received condition. Selected ECR bars were also exposed to UV exposure under Cycle 1 of ASTM G154, which consists of alternating cycles of 8 hours of UV exposure at an irradiance of 0.89 W/(m² × nm) and a temperature of 60 °C, followed by four hours of condensation (with no UV) at 50 °C. ECR was exposed to these cycles for between 100 and 1000 hours; 1000 hours of exposure under these conditions is regarded as equivalent to one year of unprotected outdoor exposure (Fedor and Brennan 2011). ASTM D3963 requires ECR to be protected from sunlight if left outdoors for longer than two months. Figure 2.2 shows ECR bars before and after 1000 hours of UV exposure. Significant discoloration of the coating is visible after exposure to UV.

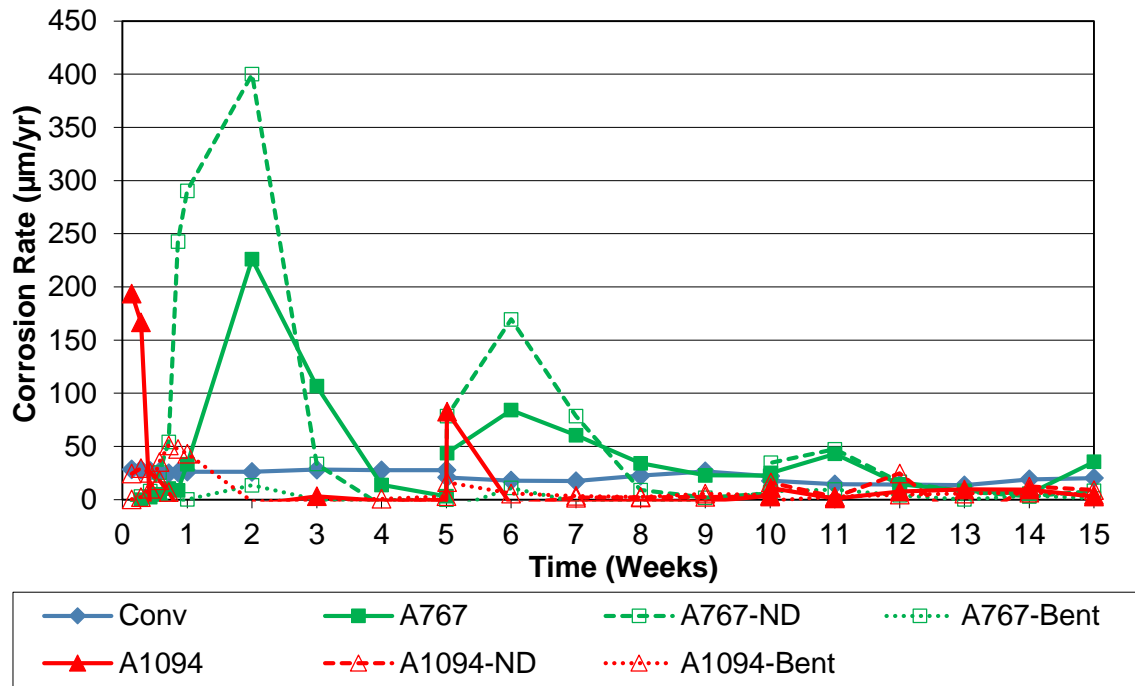
Figure 3.7 shows the average corrosion rates based on total area for A767 and A1094 galvanized reinforcement. Conventional reinforcement (representing the average of the three heats of conventional reinforcement used in this study) is shown for reference. Both A767 and A1094 reinforcement exhibited very high corrosion rates throughout testing, particularly in the first three weeks. This behavior is not unexpected; the rapid macrocell test places reinforcement in a higher pH environment than is found in concrete, and the liquid environment can interfere with the formation of the crystalline passive layer that would normally protect zinc in concrete. The behavior in the rapid macrocell test should not, therefore, be taken as representative of the behavior of galvanized reinforcement in concrete.

Figure 3.7: Rapid Macrocell Test. Average corrosion rate vs. time. Corrosion rate based on total bar area of A767 and A1094 galvanized reinforcement.

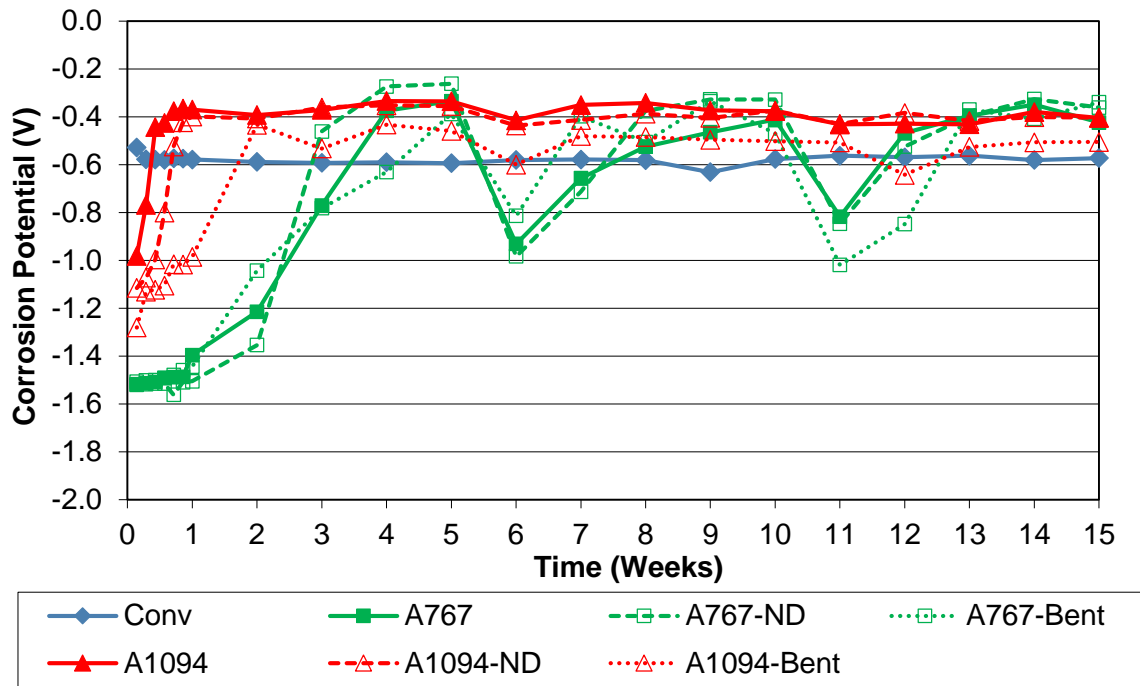
Figure 3.8 shows the average corrosion potentials for A767 and A1094 galvanized reinforcement. Both A767 and A1094 reinforcement exhibited very negative corrosion potentials at the start of testing, corresponding with the high initial corrosion rates. This behavior is expected, as zinc is a more corrosively active metal than iron. The corrosion potential for specimens with A1094 reinforcement increased to between -0.4 V and -0.6 V within the first two weeks of testing and remained there for the remainder of the test. The corrosion potential for specimens with A767 reinforcement increased to around -0.4 V by week 4. Unlike A1094 reinforcement, the corrosion potential of A767 reinforcement decreased after the solution changes at weeks 5 and 10; the potential returned to around -0.4 V within two weeks of the solution change. For both types of reinforcement, no significant differences were observed between damaged, undamaged, and bent reinforcement.

Figure 3.8: Rapid Macrocell Test. Average corrosion potentials of A767 and A1094 galvanized reinforcement vs. time.

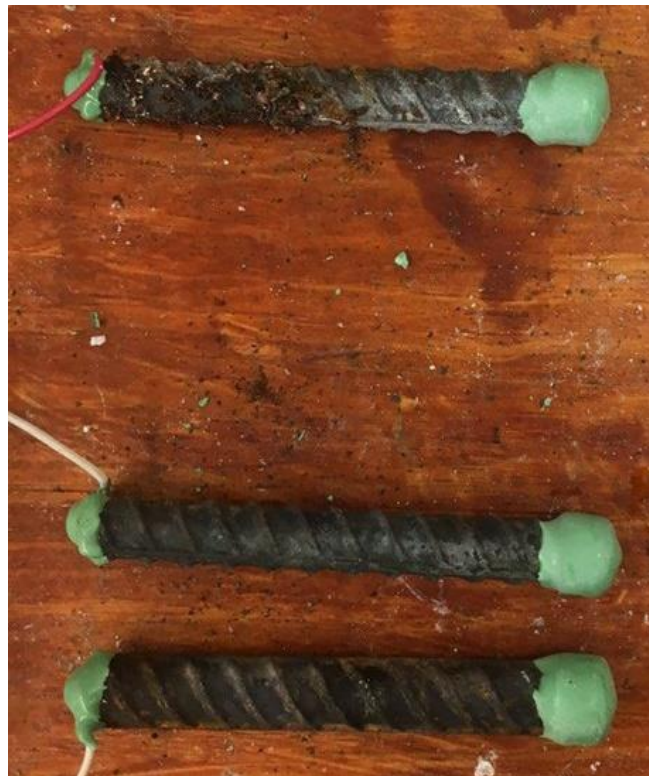
Figure 3.11 shows specimen Conv-B-5 after 15 weeks of testing, and is representative of all Conv specimens in the rapid macrocell test. Significant corrosion products are visible on the anode bar (the bar in salt solution), particularly at and above the 3-in. waterline. No corrosion products were observed on the cathode bars (the bars in pore solution without salt).

Figure 3.11: Rapid Macrocell Test. Specimen Conv-B-5 anode bar (top) and cathode bars (bottom)

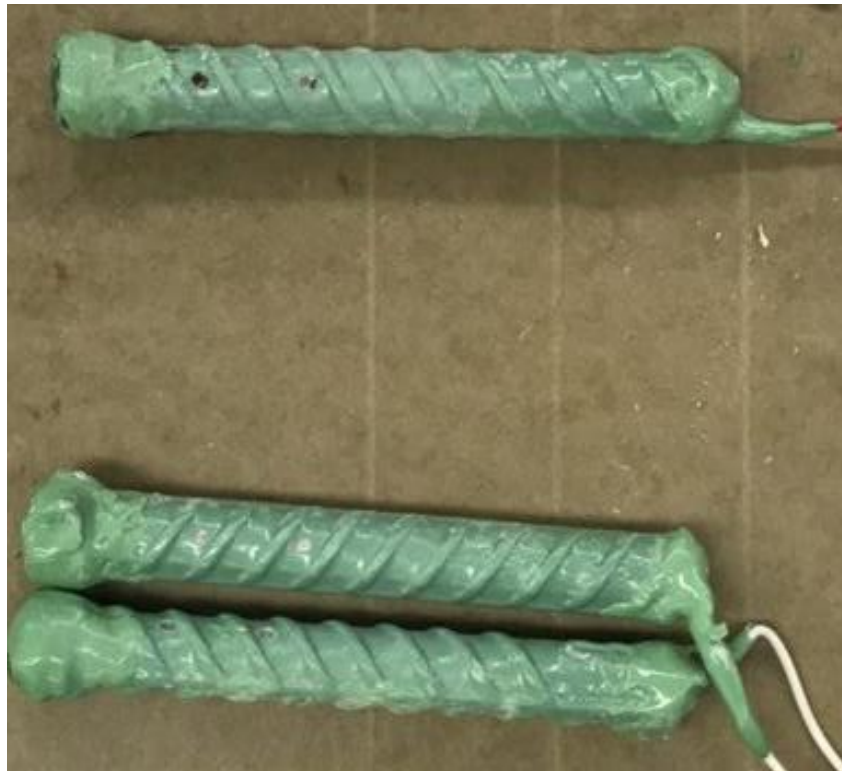
Figure 3.12 shows specimen ECR-2 after 15 weeks of testing. As observed on most damaged ECR specimens, some of the damage sites on the anode bar showed signs of rust, and other damage sites appeared clean. No blistering or other distress was visible in the undamaged portions of the coating.

Figure 3.12: Rapid Macrocell Test. Specimen ECR-2 anode bar (top) and cathode bars (bottom)

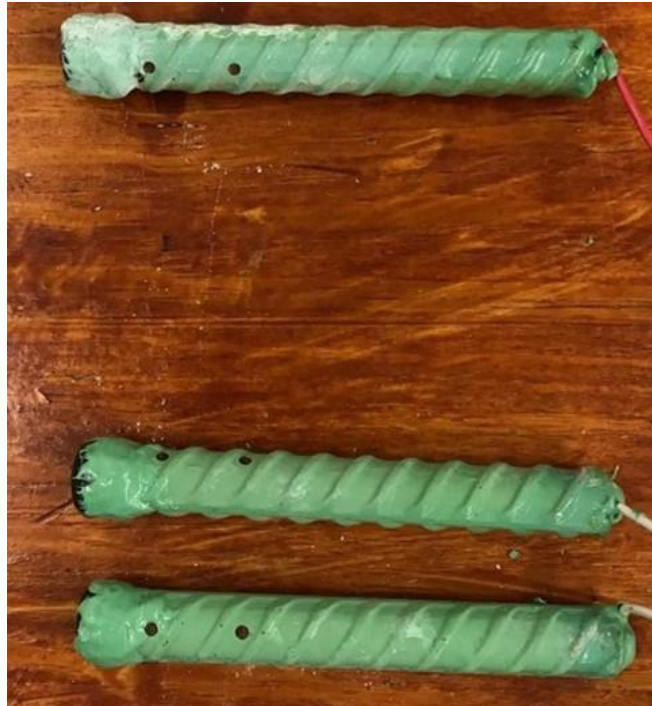
Figures 3.14 and 3.15 show specimen ECR-UV-1000-4 after 15 weeks of testing, before and after the disbondment test. Corrosion products were visible at all damage sites, and the coating readily disbonded. Discoloration of the ECR from the UV exposure was observed on all bars exposed to UV light, but no other distress was observed on the coating. Similar trends

Figure 3.14: Rapid Macrocell Test. Specimen ECR-UV-1000-4 anode bar (top) and cathode bars (bottom)

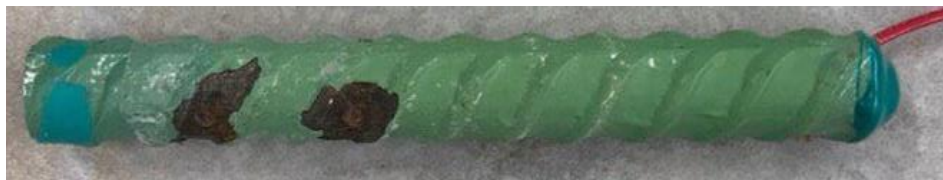
were noted on bars with lower periods of UV exposure (Figures 3.16 through 3.18). For undamaged ECR both with and without UV exposure, no disbondment was observed on any of the bars (Figure 3.19).

Figure 3.16: Rapid Macrocell Test. Specimen ECR-UV-500-5 anode bar after disbondment test

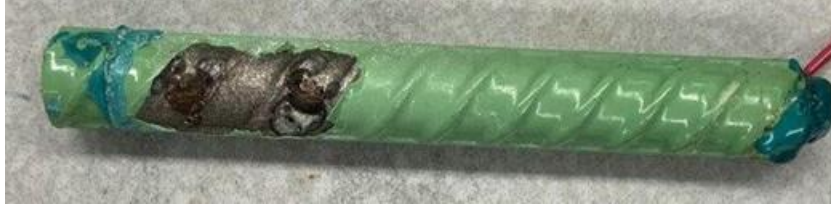
Figure 3.17: Rapid Macrocell Test. Specimen ECR2-UV-200-3 anode bar after disbondment test

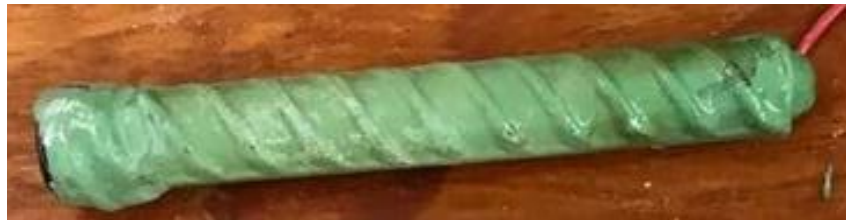
Figure 3.19: Rapid Macrocell Test. Specimen ECR-ND-6 anode bar after disbondment test

Table 3.5 summarizes the measured disbonded area on the ECR specimens at the end of testing. As described in Chapter 2, disbondment that extended more than 0.5 in. from the intentional damage site in all directions was classified as total disbondment and was assigned a disbonded area of 1.05 in.² As shown in the table, damaged ECR not exposed to UV light exhibited a relatively low amount of disbondment, averaging 0.057 in.²; any amount of UV exposure resulted in significant increases in disbondment, often by an order of magnitude compared to the specimens with no UV exposure. For the ECR2 specimens, disbondment appeared to increase as the amount of UV exposure increased; this trend was not observed on the first heat of ECR bars. Undamaged ECR, both with and without UV exposure, did not exhibit disbondment.

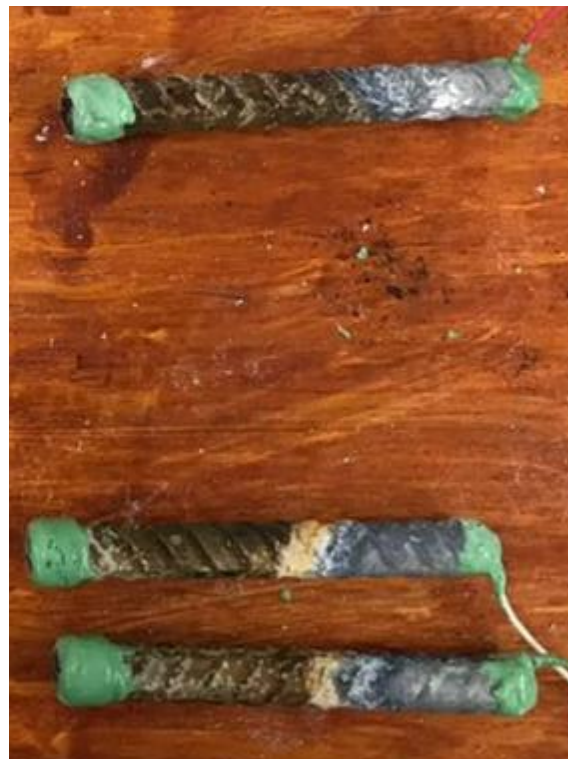
Figures 3.20 and 3.21 show A767 and A1094 reinforcement after 15 weeks of testing and are representative of all galvanized bars in this study. Heavy corrosion was observed on both the anode and cathode bars. This suggests corrosion was due to the high pH of the macrocell pore solution, and not solely due to chloride exposure. The rapid macrocell test results should, therefore, not be considered as representative of the performance of galvanized reinforcement in the concrete.

Figure 3.20: Rapid Macrocell Test. Specimen A767-1 anode bar (top) and cathode bars (bottom)

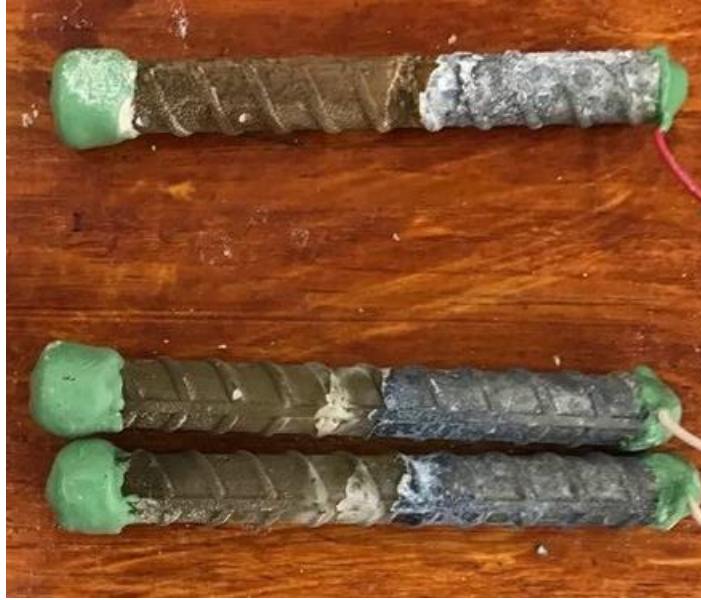
Figure 3.21: Rapid Macrocell Test. Specimen A1094-4 anode bar (top) and cathode bars (bottom)

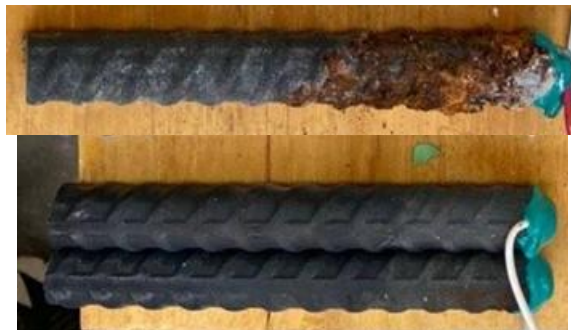
Figure 3.22 shows specimen A1035-6 after 15 weeks of testing, and is representative of all A1035 specimens in the rapid macrocell test. Significant corrosion products are visible on the anode bar, particularly at and above the 3-in. waterline. No corrosion products were observed on the cathode bars.

Figure 3.22: Rapid Macrocell Test. Specimen A1035-6 anode bar (top) and cathode bars (bottom)

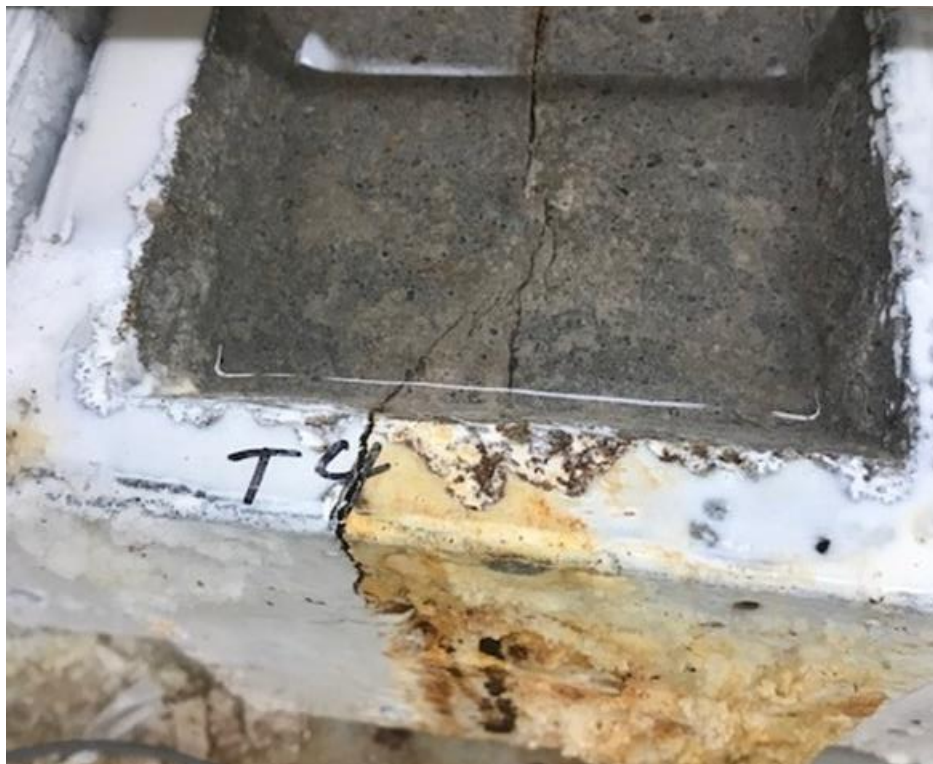
In the cracked beam test, two specimens with Conv-B reinforcement, Conv-B-3 and Conv-B-4, exhibited enough corrosion to crack the concrete (Figure 3.25). These specimens were removed from testing early, at weeks 49 and 67, respectively.

Figure 3.25: Cracked beam test. Cracking of concrete in specimen Conv-B-3.

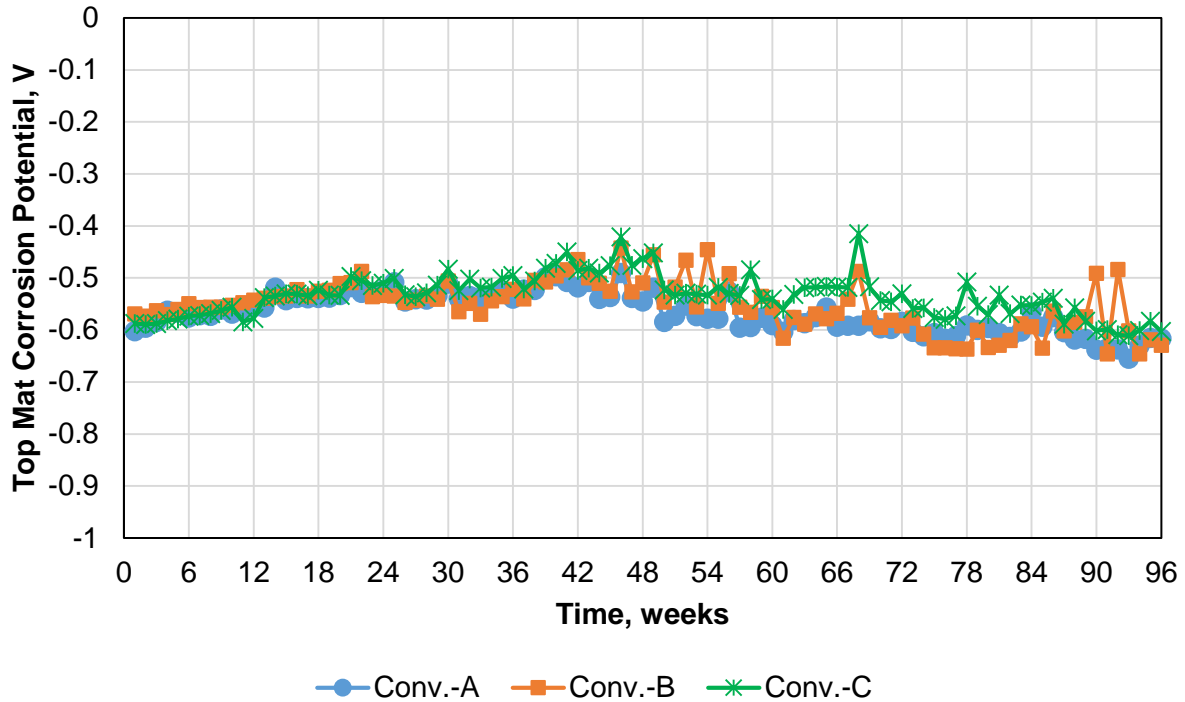
Figures 3.26 and 3.27 show the average corrosion potentials versus a copper/copper sulfate electrode (CSE) for the three heats of conventional reinforcement under the Southern Exposure and cracked beam tests, respectively. At the initiation of the Southern Exposure test (Figure 3.26), all three heats of steel exhibited a corrosion potential of approximately -0.200 V vs. CSE, indicating a $>90\%$ probability of no corrosion per ASTM C876. As corrosion initiated, the corrosion potential became more negative, reaching values between -0.450 V and -0.600 V by week 48 and remaining there for the remainder of the test. Throughout the duration of the cracked beam test (Figure 3.27), all three heats of steel exhibited corrosion potentials more negative than -0.400 V, indicating $>90\%$ probability of active corrosion per ASTM C876.

Figure 3.27: Cracked beam test. Average corrosion potentials of conventional reinforcement vs. time.

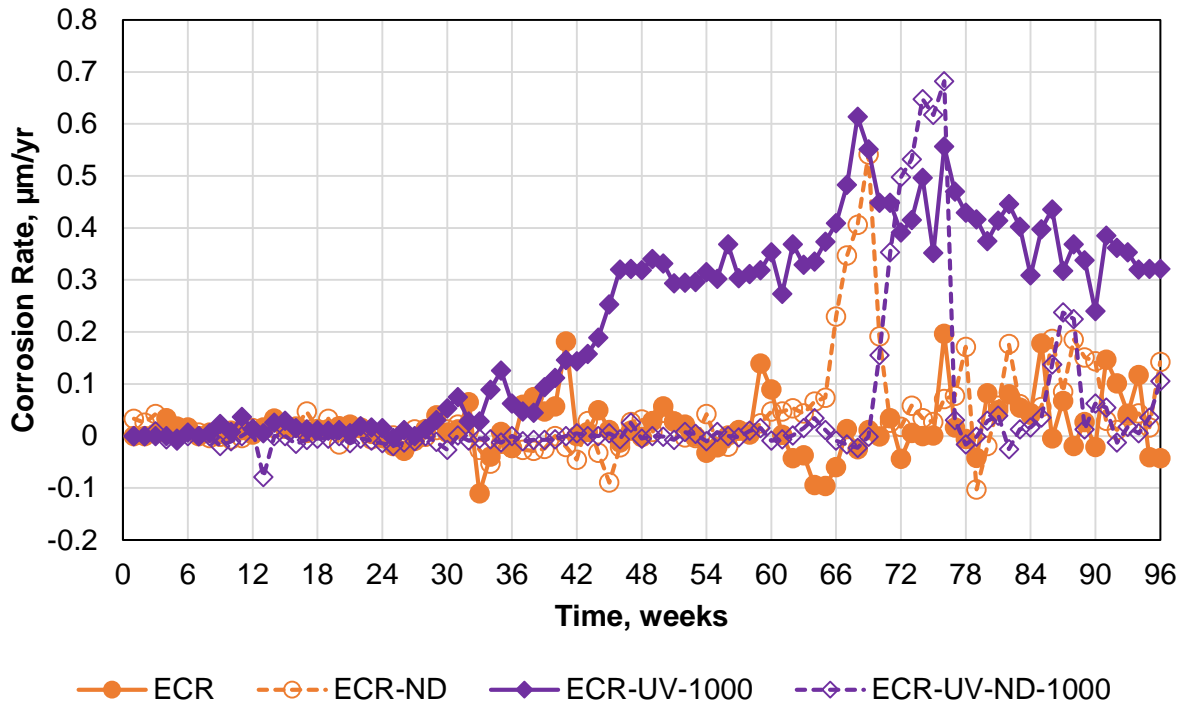
Figures 3.28 and 3.29 show the average macrocell corrosion rate based on total bar area for specimens with damaged epoxy-coated reinforcement in the Southern Exposure and cracked beam tests, respectively. In the Southern Exposure test, damaged ECR with no UV exposure exhibited no corrosion activity through 30 weeks of testing. After 30 weeks, the corrosion rate periodically jumped to as high as $0.2 \mu\text{m}/\text{yr}$ for limited periods of time before returning to 0. Damaged ECR with 1000 hours of UV exposure exhibited corrosion at an earlier age than damaged ECR with no UV exposure. Damaged ECR with UV exposure started showing corrosion activity after 24 weeks; after week 48, corrosion rates were consistently above $0.3 \mu\text{m}/\text{yr}$, peaking at over $0.6 \mu\text{m}/\text{yr}$. Undamaged ECR exhibited no significant corrosion. In the cracked beam test, damaged ECR with UV exposure exhibited corrosion from the start of testing, quickly exceeding and an average value of $2 \mu\text{m}/\text{yr}$. After week 20, the corrosion activity of ECR-UV-1000 declined, to around $1 \mu\text{m}/\text{yr}$ by week 32, where it remained for the remainder of testing. Damaged ECR without UV exposure also exhibited corrosion activity from the start of testing, but at much lower rates— 0.1 to $0.2 \mu\text{m}/\text{yr}$. Undamaged ECR with UV exposure exhibited corrosion rates in the range of 0.1 to $0.2 \mu\text{m}/\text{yr}$ for the first 72 weeks of testing—comparable to damaged ECR without UV exposure. After week 72, however, the corrosion rate of ECR-UV-ND-1000 began to increase, with spikes in corrosion rate as high as $0.8 \mu\text{m}/\text{yr}$. Undamaged ECR without UV exposure only exhibited isolated single-week spikes of corrosion activity.

Figure 3.28: Southern Exposure test. Average macrocell corrosion rate vs. time. Corrosion rate based on total bar area of epoxy-coated reinforcement.

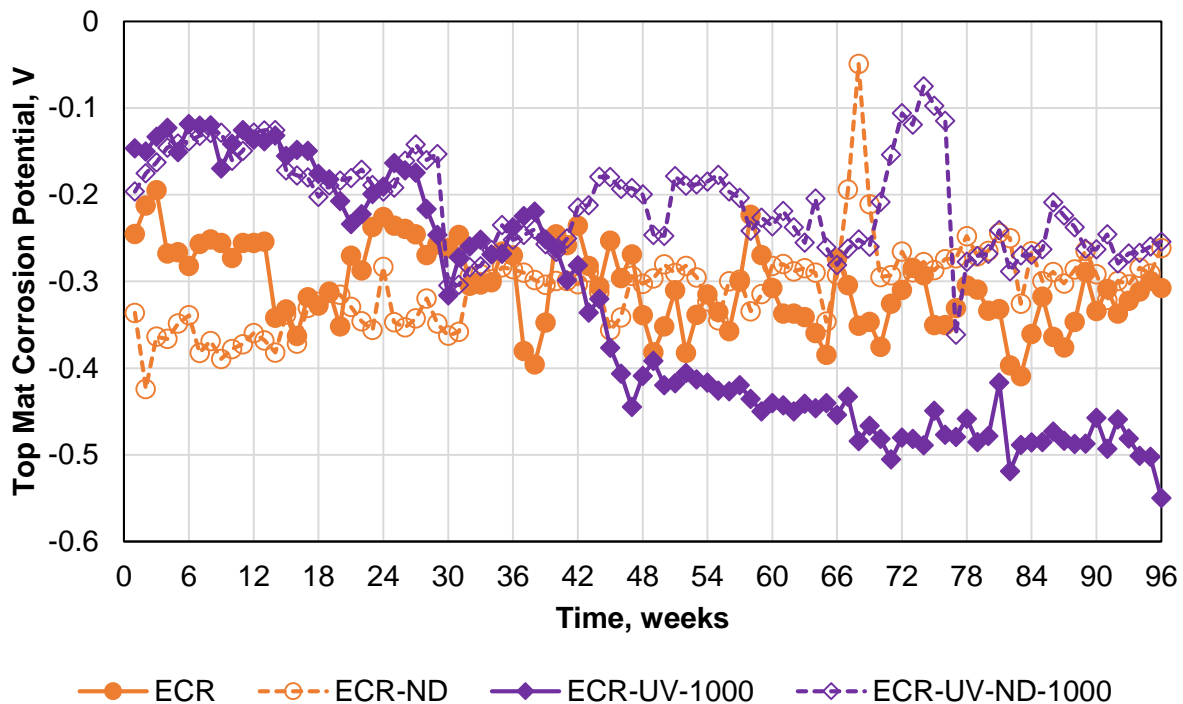
Figure 3.30: Southern Exposure test. Average corrosion potentials of epoxy-coated reinforcement vs. time.

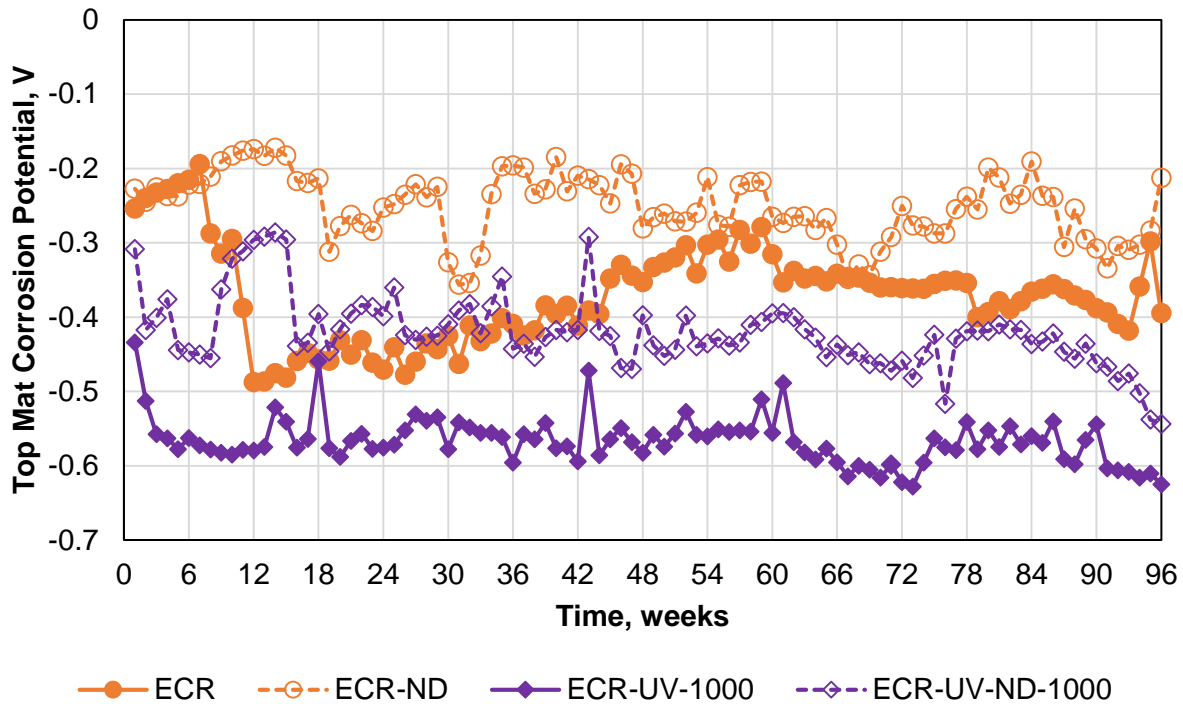
In the cracked beam test (Figure 3.31), specimens generally exhibited corrosion potentials that remained approximately constant after the first few weeks of testing. Specimens with UV exposure consistently exhibited more negative potentials than specimens without UV exposure. Damaged ECR with 1000 hours of UV exposure consistently exhibited the most negative potentials, around -0.6 V. Damaged ECR without UV exposure exhibited potentials around -0.2 V early in testing; the potential rapidly dropped to -0.5 V after week 6 before recovering to between -0.3 and -0.4 V. Undamaged ECR with UV exposure exhibited potentials between -0.4 and -0.5 V, whereas undamaged ECR with UV exposure generally exhibited potentials between -0.2 and -0.3 V.

Figure 3.31: Cracked beam test. Average corrosion potentials of epoxy-coated reinforcement vs. time.

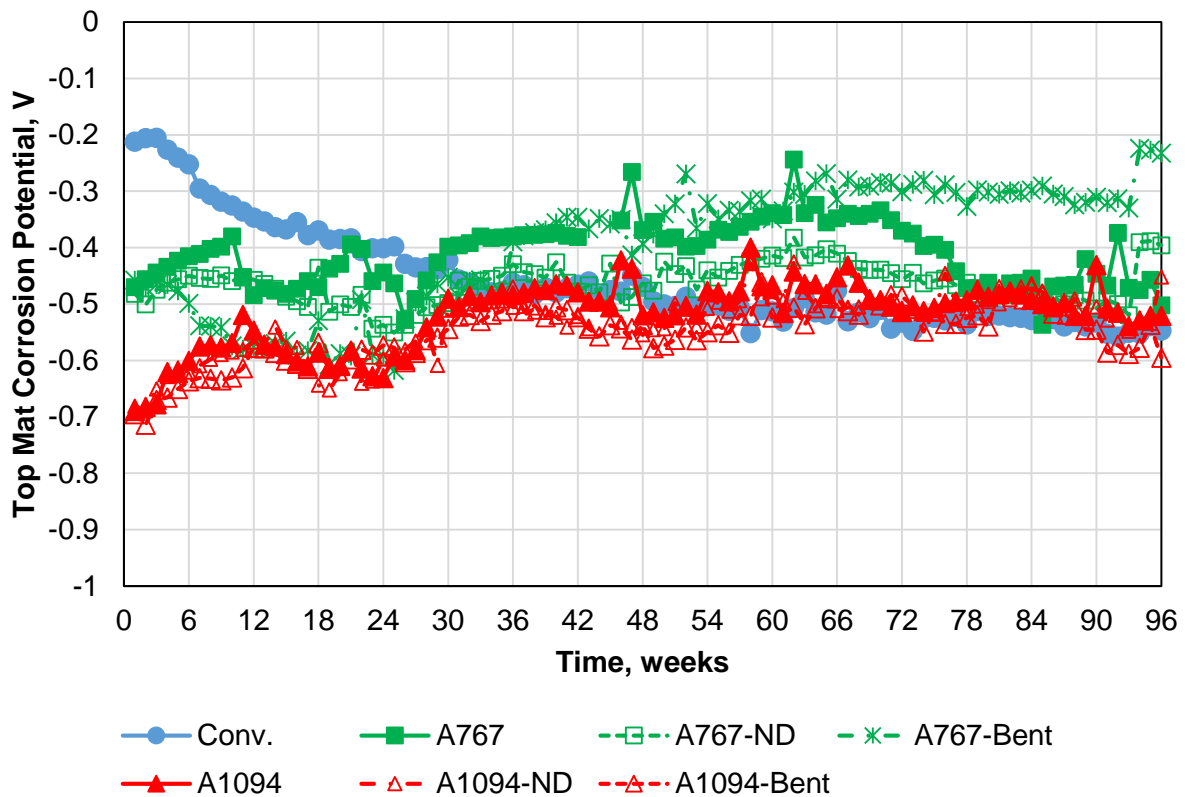
Figures 3.34 and 3.35 show the average corrosion potentials versus a CSE for A767 and A1094 galvanized reinforcement in the Southern Exposure and cracked beam tests, respectively. In the Southern Exposure test, damaged and undamaged A767 had an initial potential around -0.5 V, while damaged and undamaged A1094 had an initial potential around -0.7 V. The potentials for A767 and A1094 gradually increased over the first 30 weeks (reaching -0.4 and -0.5 V, respectively), then remained approximately constant. A767 reinforcement exhibited a drop in potential after 72 weeks in the Southern Exposure test; other specimens with galvanized reinforcement exhibited stable potentials. In the cracked beam test, damaged and undamaged A767 had an initial potential around -0.8 V, while damaged and undamaged A1094 had an initial potential around -1.0 V. The potentials for A767 and A1094 gradually increased over the first 18 weeks (reaching -0.5 and -0.6 V, respectively), then remained approximately constant.

Figure 3.34: Southern Exposure test. Average corrosion potentials of conventional, A767, and A1094 reinforcement vs. time.

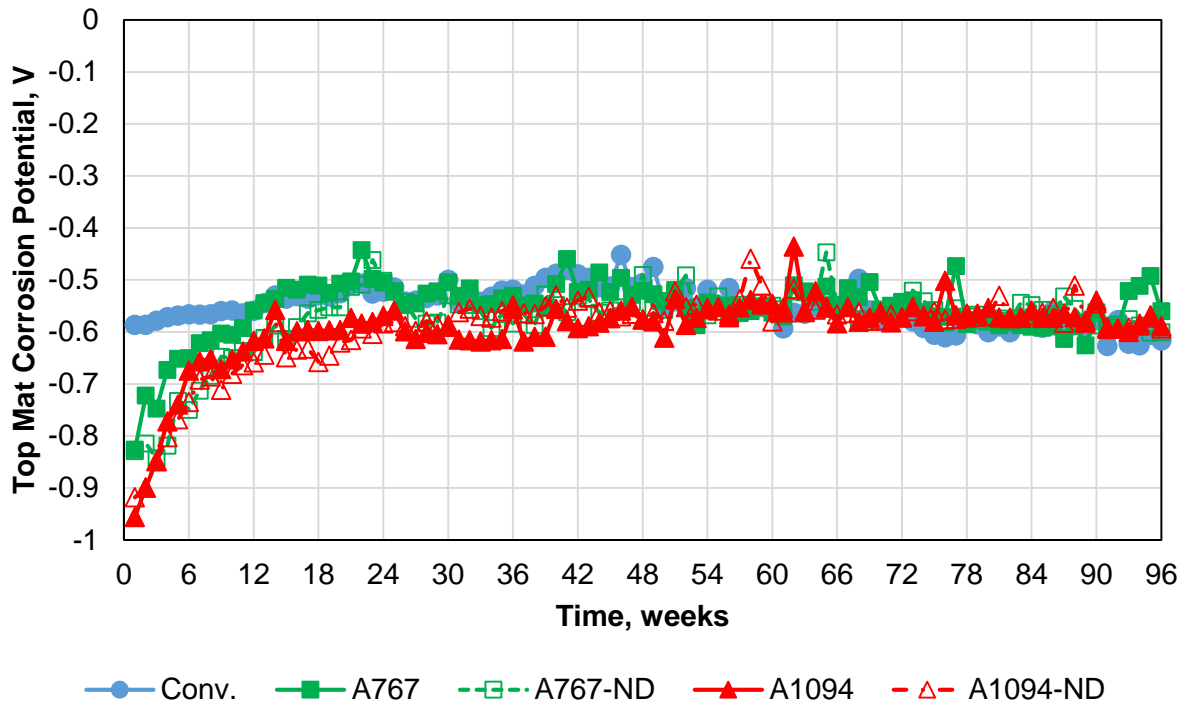
Figure 3.35: Cracked beam test. Average corrosion potentials of conventional, A767, and A1094 reinforcement vs. time.

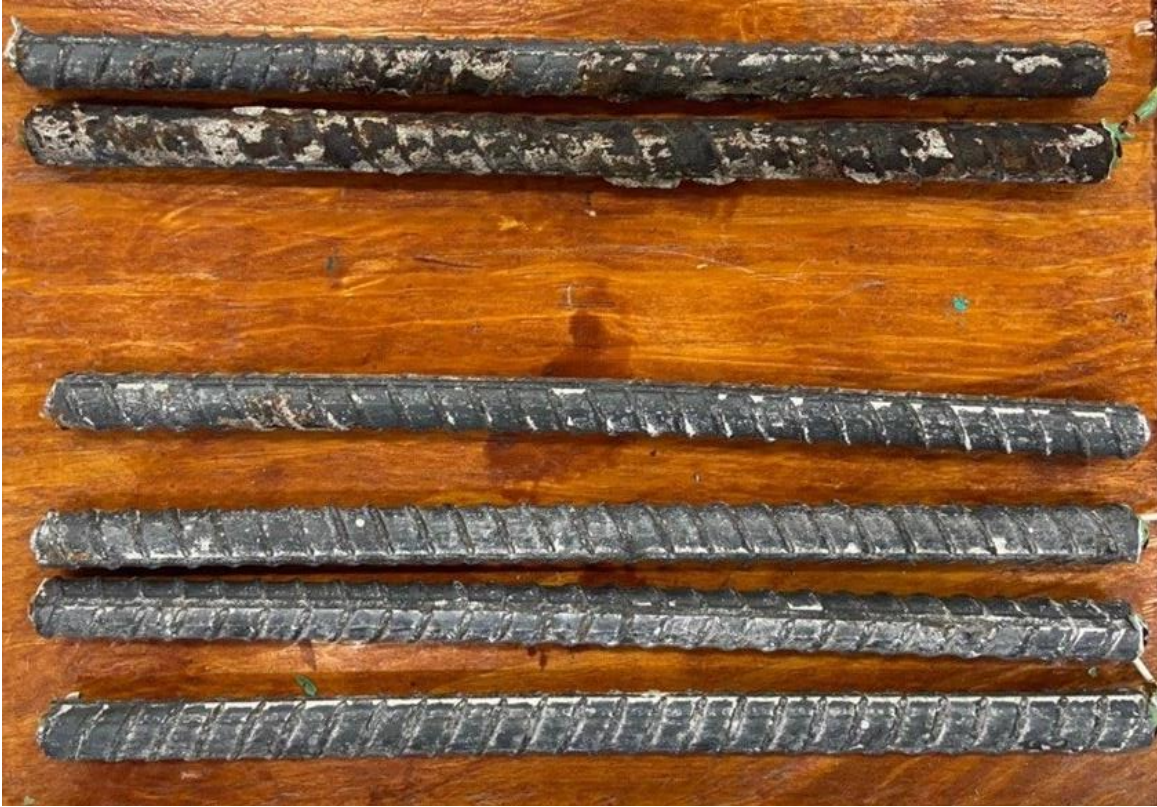
Figure 3.40 shows the bars from Southern Exposure specimen Conv-C-1 after 96 weeks of testing, and is representative of all conventional reinforcement in the Southern Exposure test. As shown in the photo, moderate amounts of corrosion are visible on both bars from the top mat of steel, although corrosion did not cover the entirety of both bars. This corrosion was frequently sufficient to cause staining on the surface of the specimen (Figure 3.41). No corrosion products were visible on the bars from the bottom mat of steel.

Figure 3.40: Southern Exposure test. Specimen Conv-C-1 after 96 weeks of testing. Top mat (top) and bottom mat (bottom).

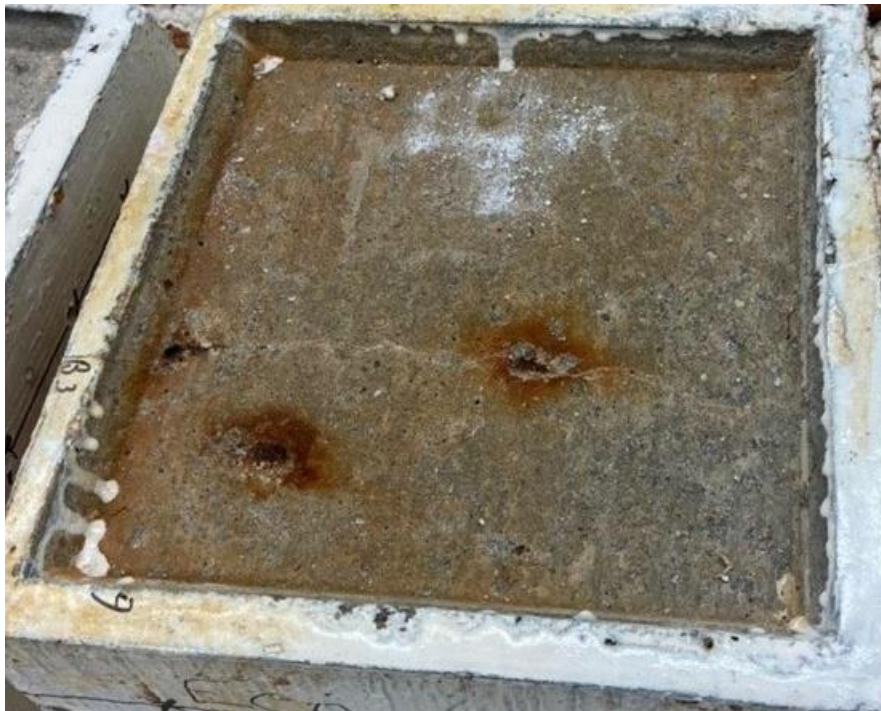
Figure 3.41: Southern Exposure test. Surface staining on specimen with conventional reinforcement.

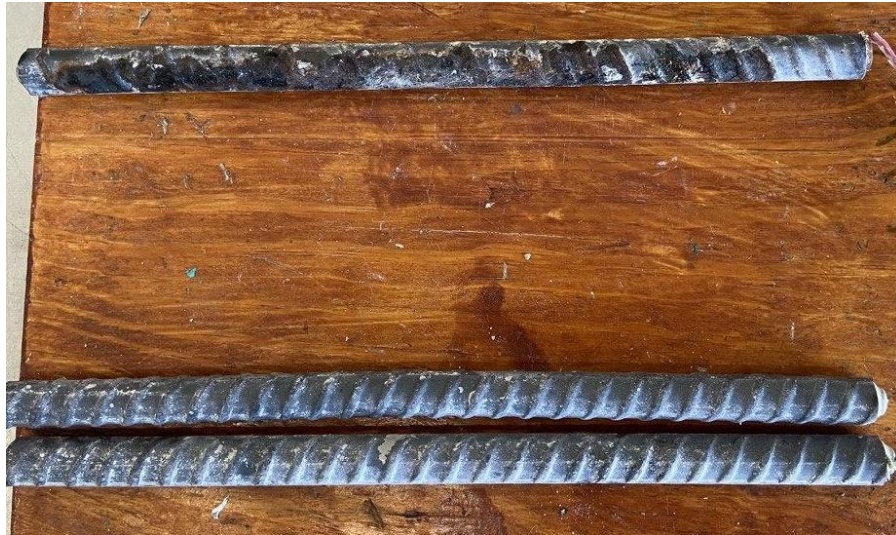
Figure 3.42 shows the bars from cracked beam specimen Conv-B-4 after 96 weeks of testing, and is representative of all conventional reinforcement. Moderate to heavy amounts of corrosion are visible on the top mat of steel, with some pitting and deeper localized corrosion occurring, particularly in the region directly under the 6-in. simulated crack. As was the case with Southern Exposure specimens, most cracked beam specimens with conventional reinforcement exhibited staining on the surface (Figure 3.43). Light or no corrosion products were visible on the bars from the bottom mat of steel.

Figure 3.42: Cracked beam test. Specimen Conv-B-4 after 96 weeks of testing. Top mat (top) and bottom mat (bottom).

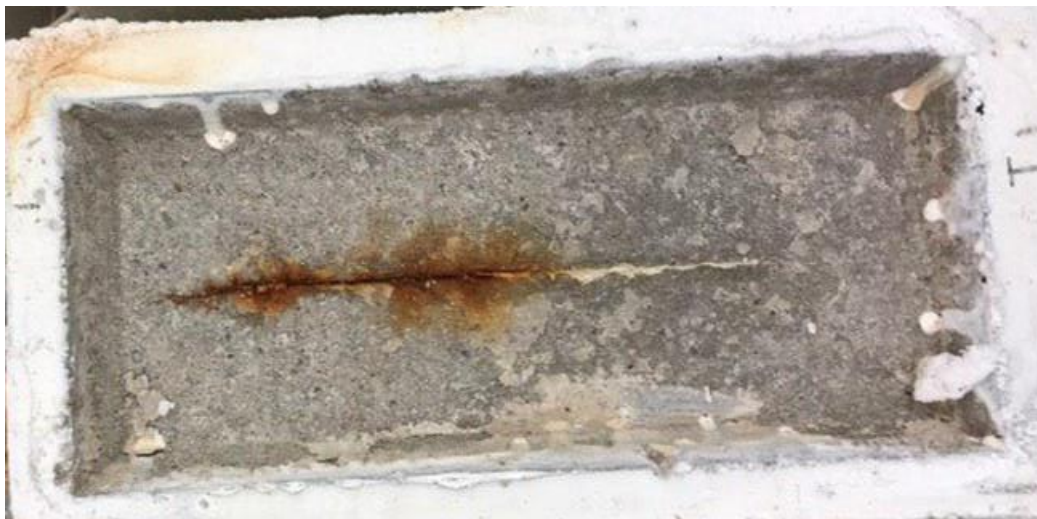
Figure 3.43: Cracked beam test. Surface staining on specimen with conventional reinforcement.

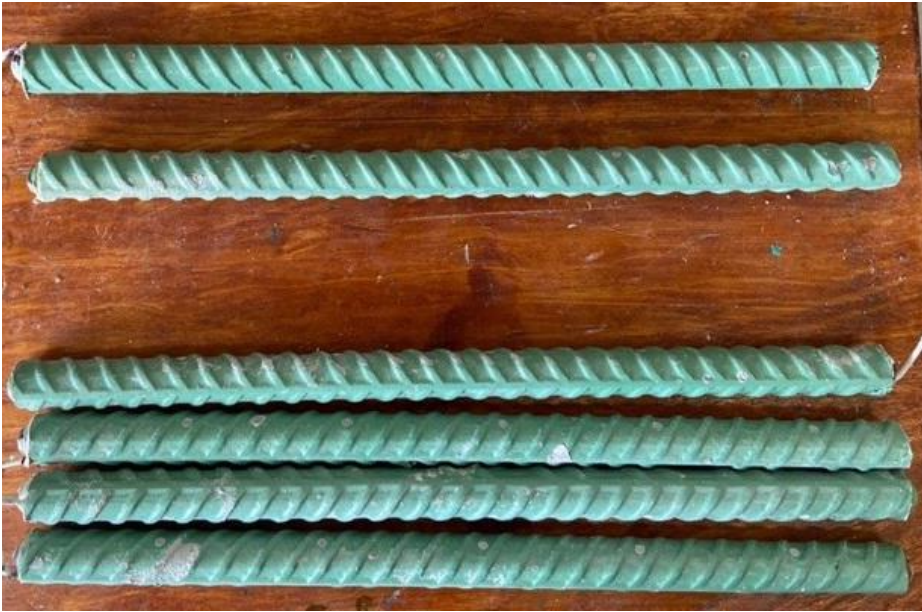
Figure 3.44 shows the bars from Southern Exposure specimen ECR-2 after 96 weeks of testing, and is representative of all damaged ECR. As shown in the photo, minimal amounts of corrosion damage are visible; corrosion was typically limited to small amounts at the damage sites in the epoxy. No significant disbondment was observed on any Southern Exposure

Figure 3.44: Southern Exposure test. Specimen ECR-2 after 96 weeks of testing. Top mat (top) and bottom mat (bottom).

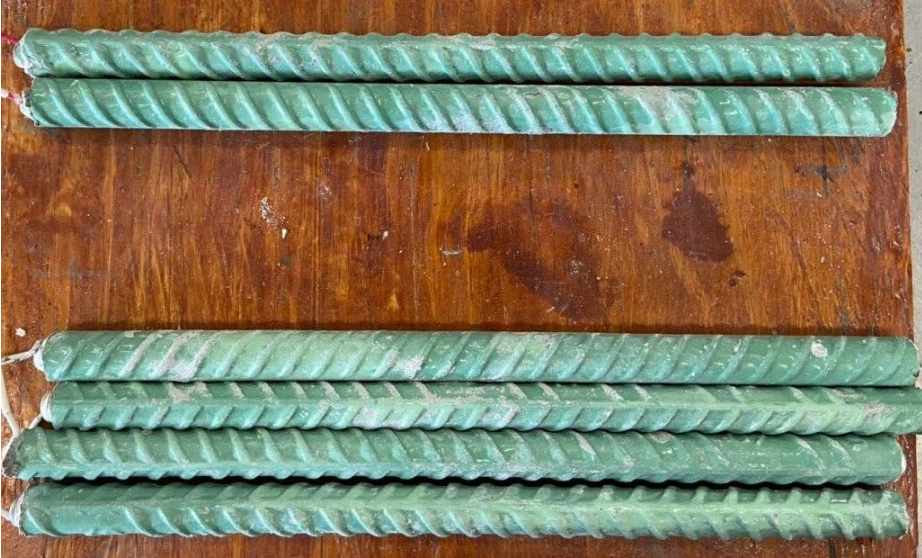
specimen (Figure 3.45). Figure 3.46 shows undamaged ECR specimen ECR-ND-2 after 96 weeks of testing. No corrosion was observed on any ECR-ND specimen in the Southern Exposure test.

Figure 3.46: Southern Exposure test. Specimen ECR-ND-2 after 96 weeks of testing. Top mat (top) and bottom mat (bottom).

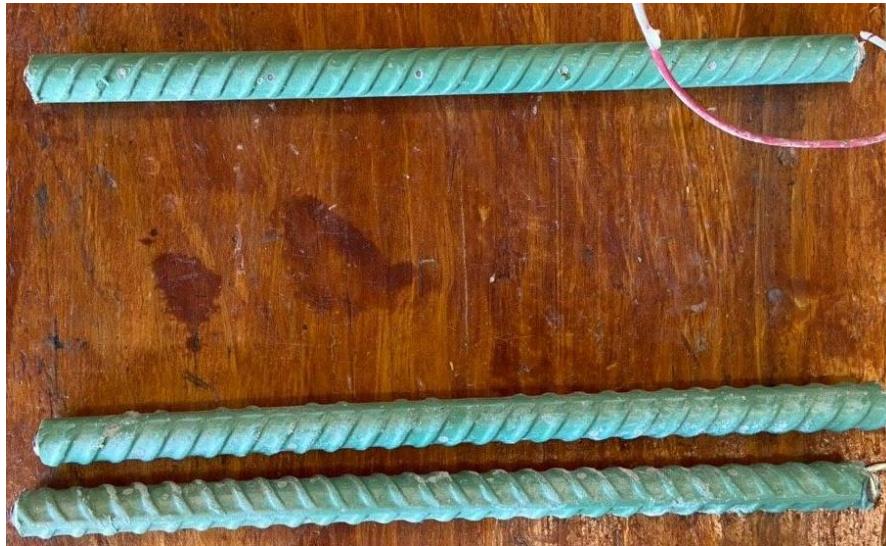
Figure 3.47 shows the bars from cracked beam specimen ECR-3 after 96 weeks of testing, and is representative of all damaged ECR. Minimal amounts of corrosion damage are visible on damaged ECR specimens; corrosion was limited to small amounts at the damage sites in the top mat of steel. Unlike the bars in the Southern Exposure test, damaged ECR bars exhibited significant disbondment after exposure in the cracked beam test; corrosion had spread underneath the undamaged portions of the coating (Figure 3.48)

Figure 3.47: Cracked beam test. Specimen ECR-3 after 96 weeks of testing. Top mat (top) and bottom mat (bottom).

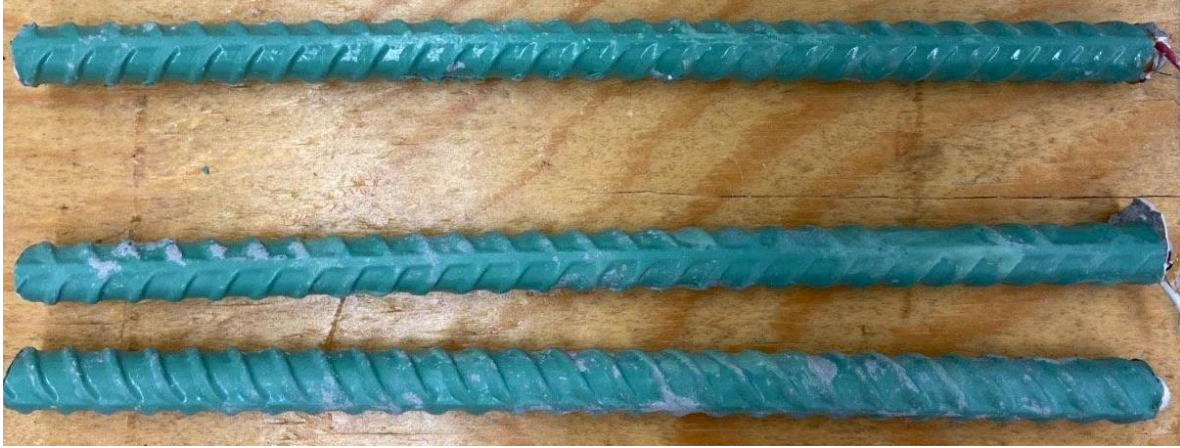
Figures 3.49 and 3.50 show photos of undamaged ECR after 96 weeks of testing in the cracked beam test. Two of the undamaged ECR specimens showed no visible corrosion (Figure 3.49); however, specimen ECR-ND-1 showed some rust buildup at an unnoticed holiday in the coating (Figure 3.50).

Figure 3.49: Cracked beam test. Specimen ECR-ND-2 after 96 weeks of testing. Top mat (top) and bottom mat (bottom).

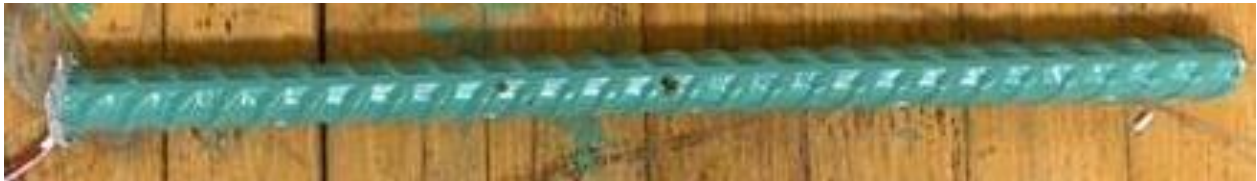
Figure 3.50: Top bar of cracked beam test. Specimen ECR-ND-1 after 96 weeks of testing.

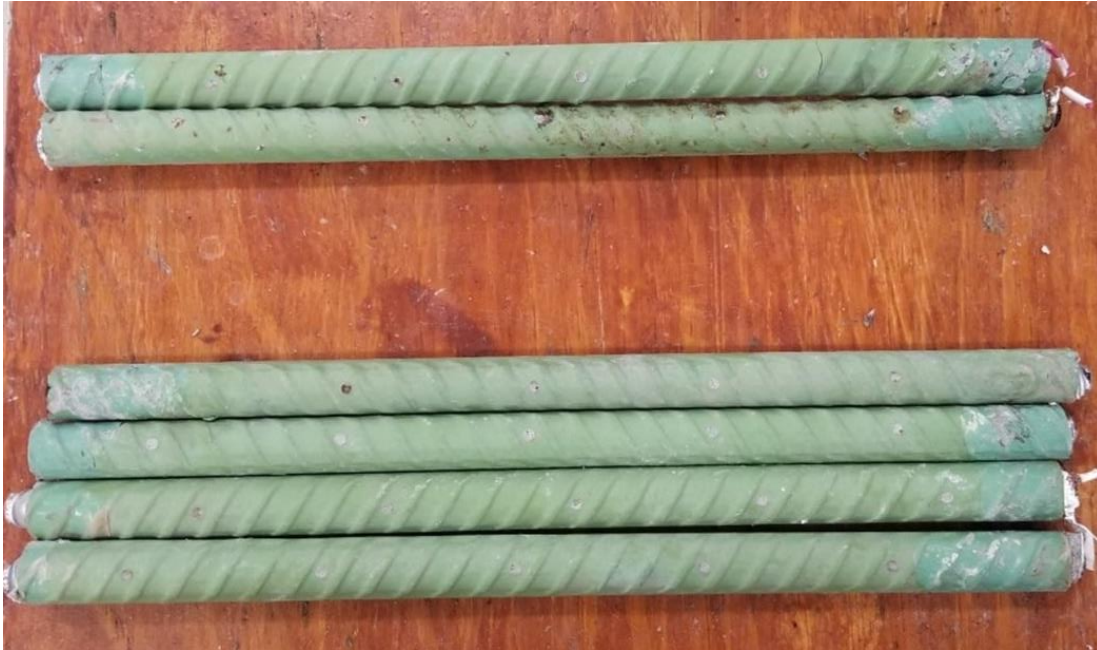
Figure 3.51 shows the bars from Southern Exposure specimen ECR-UV-1000-1 after 96 weeks of testing, and is representative of all ECR-UV-1000 specimens. Much larger amounts of corrosion damage are visible than was the case for damaged ECR specimens without UV exposure. Damaged ECR bars exhibited significant disbondment after exposure, and for most bars, the entire coating could be easily removed (Figure 3.52)

Figure 3.51: Southern Exposure test. Specimen ECR-UV-1000-1 after 96 weeks of testing. Top mat (top) and bottom mat (bottom).

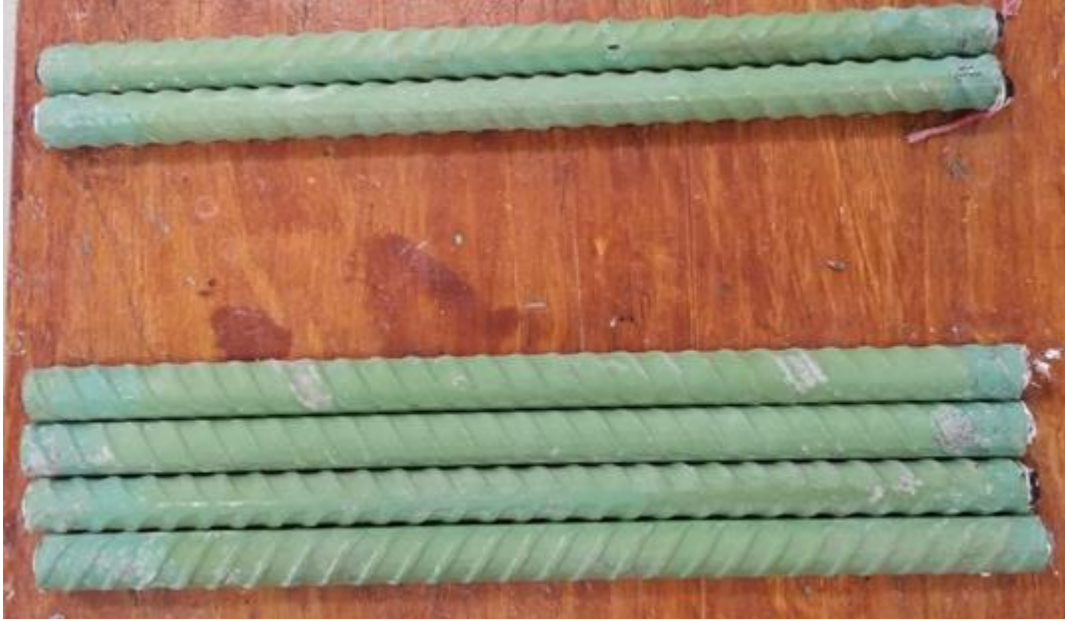
Figure 3.53 shows the bars from cracked beam specimen ECR-UV-1000-ND-1 after 96 weeks of testing, and is representative of all ECR-UV-1000-ND specimens. Minimal to no corrosion damage was observed on the bars, but discoloration from the UV exposure was visible.

Figure 3.53: Southern Exposure test. Specimen ECR-UV-1000-ND-1 after 96 weeks of testing. Top mat (top) and bottom mat (bottom).
