FINAL REPORT ~ FHWA-OK-20-06

EVALUATING THE PERFORMANCE OF EXISTING REINFORCEMENT FOR OKLAHOMA BRIDGES

Department of Civil, Environmental & Architectural Engineering
The University of Kansas
Lawrence, Kansas

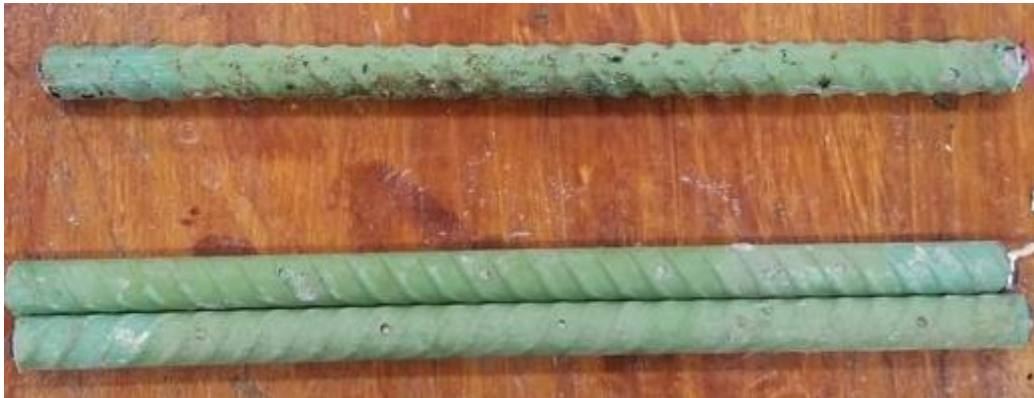
Figure 3.54 shows the bars from cracked beam specimen ECR-UV-1000-1 after 96 weeks of testing, and is representative of all ECR-UV-1000 specimens. Much larger amounts of corrosion damage are visible than was the case for damaged ECR specimens without UV exposure; blistering and cracking of the coating was observed on all top bars. Damaged ECR bars exhibited significant disbondment after exposure, and in every bar evaluated the entire coating could be easily removed (Figure 3.55)

Figure 3.54: Cracked beam test. Specimen ECR-UV-1000-2 after 96 weeks of testing. Top mat (top) and bottom mat (bottom).

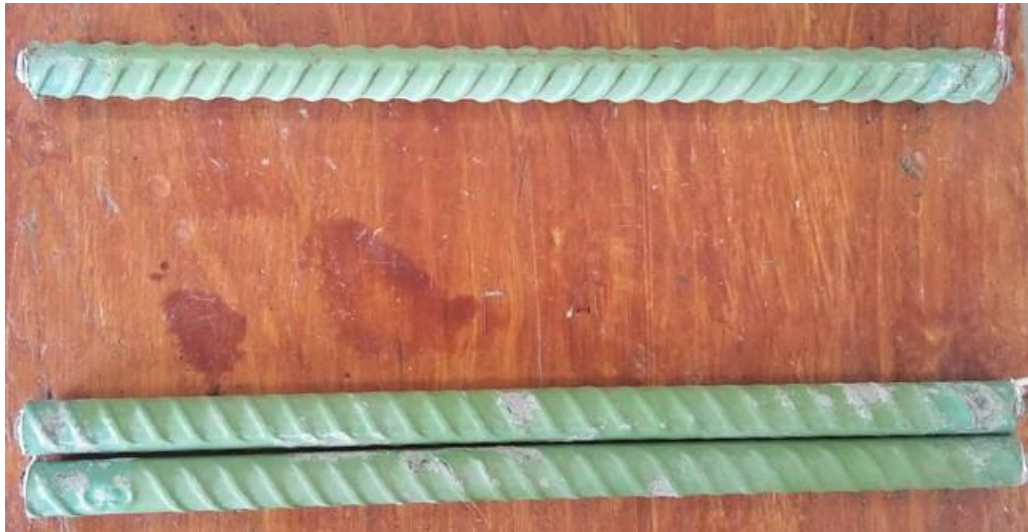
Figure 3.56 shows the bars from cracked beam specimen ECR-UV-1000-ND-1 after 96 weeks of testing, and is representative of all ECR-UV-1000-ND specimens. As was the case for Southern Exposure specimens, minimal to no corrosion damage was observed on the bars, but discoloration from the UV exposure was visible.

Figure 3.56: Cracked beam test. Specimen ECR-UV-1000-ND-1 after 96 weeks of testing. Top mat (top) and bottom mat (bottom).

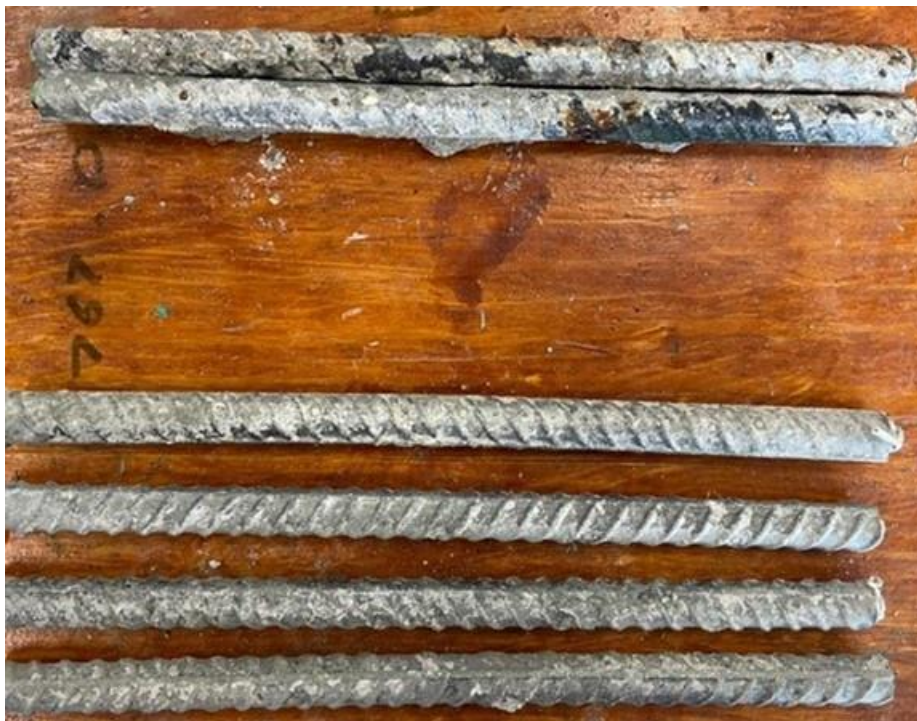
Figure 3.57 shows the bars from Southern Exposure specimen A767-3 after 96 weeks of testing. The top mat of steel exhibited moderate amounts of corrosion (heavy in places) with both zinc corrosion products (white) and steel corrosion products (orange-brown) visible. Corrosion was uneven, with the coating intact in several places but the underlying intermetallic layers visible in others. On several A767 specimens, corrosion was also present on the bottom bars (Figure 3.58), explaining the “negative” corrosion loss observed on some A767 specimens.

Figure 3.57: Southern Exposure test. Specimen A767-3 after 96 weeks of testing. Top mat (top) and bottom mat (bottom).

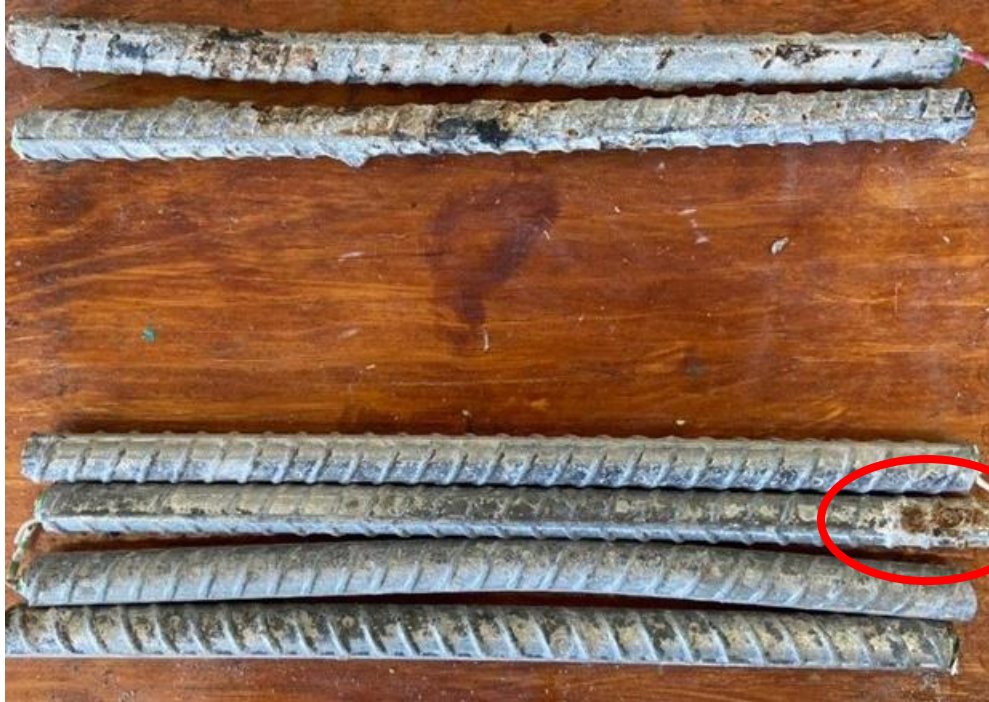
Figure 3.58: Southern Exposure test. Specimen A767-2 after 96 weeks of testing. Top mat (top) and bottom mat (bottom). Corrosion on bottom mat circled.

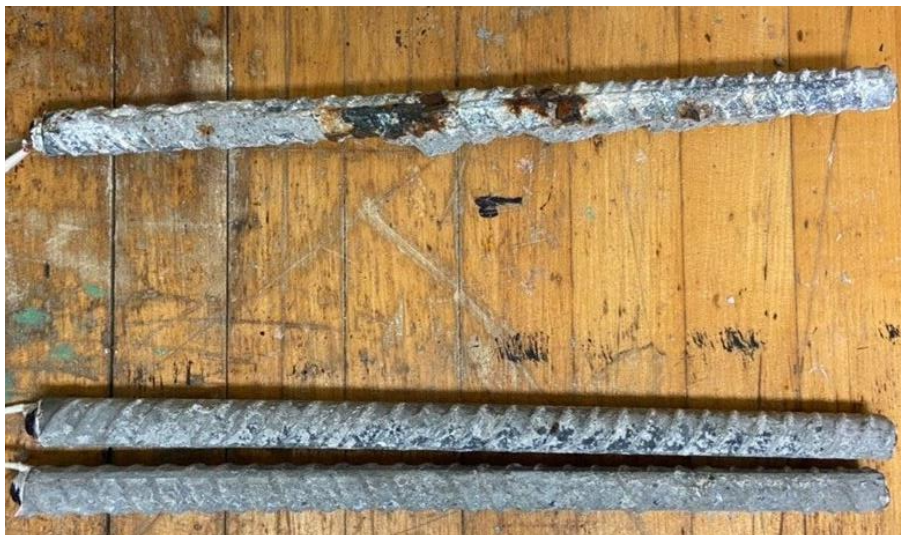
Figure 3.59 shows the bars from cracked beam specimen A767-3 after 96 weeks of testing. As observed for the Southern Exposure specimens, the top mat of steel exhibited moderate amounts of corrosion (heavy in places) with both zinc corrosion products (white) and steel corrosion products (orange-brown) visible. Fewer white zinc corrosion products were visible on the bottom bars, with isolated areas of steel corrosion products visible.

Figure 3.59: Cracked beam test. Specimen A767-3 after 96 weeks of testing. Top mat (top) and bottom mat (bottom).

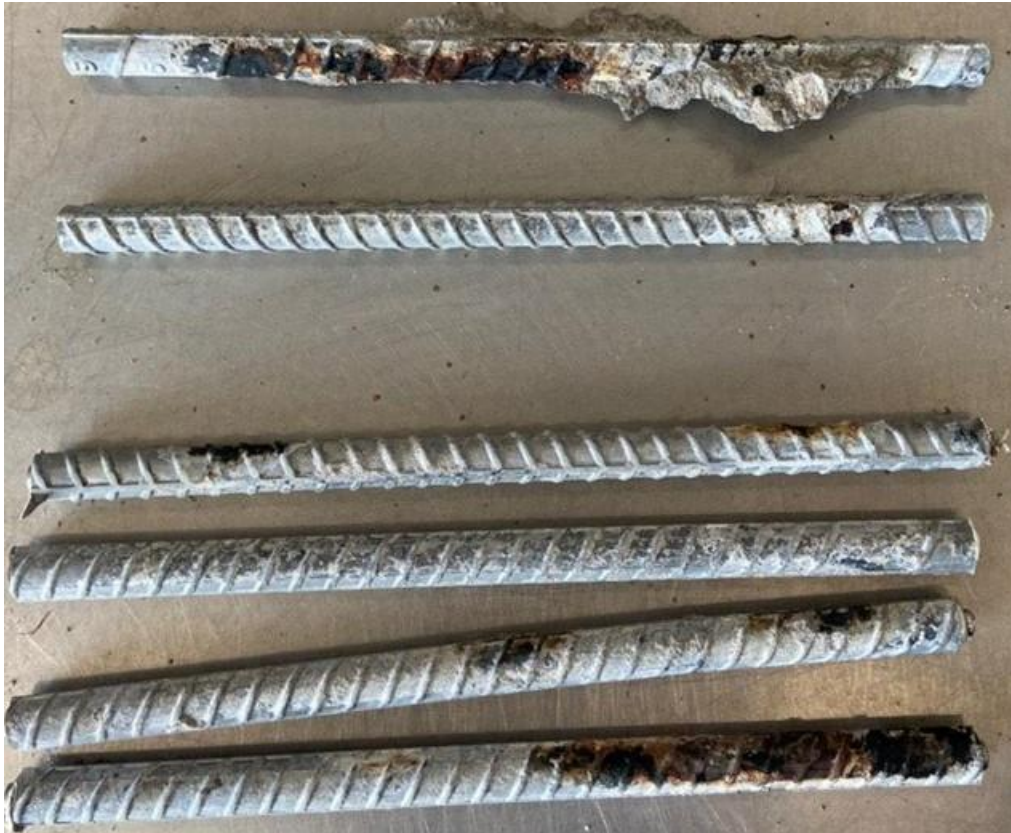
Figure 3.60 shows the bars from Southern Exposure specimen A1094-4 after 96 weeks of testing. The top mat of steel exhibited moderate to heavy corrosion with both zinc corrosion products (white) and steel corrosion products (orange-brown) visible. As for the A767 specimens, corrosion was uneven, with undisturbed zinc adjacent to exposed underlying intermetallic layers. As observed on the A767 specimens, corrosion was also present on the bottom mat on some specimens, explaining the “negative” corrosion losses observed on these specimens.

Figure 3.60: Southern Exposure test. Specimen A1094-4 after 96 weeks of testing. Top mat (top) and bottom mat (bottom).

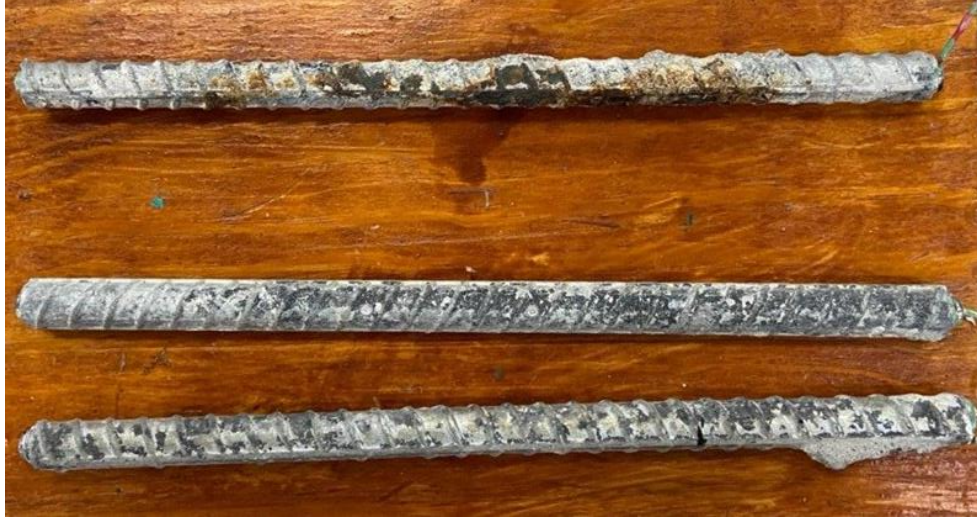
Figure 3.61: Cracked beam test. Specimen A1094-6 after 96 weeks of testing. Top mat (top) and bottom mat (bottom).

Figure 3.61 shows the bars from cracked beam specimen A1094-6 after 96 weeks of testing. The top mat of steel exhibited moderate amounts of corrosion with both zinc corrosion products (white) and steel corrosion products (orange-brown) visible. Again, limited amounts of zinc corrosion products were observed on the bottom mat.

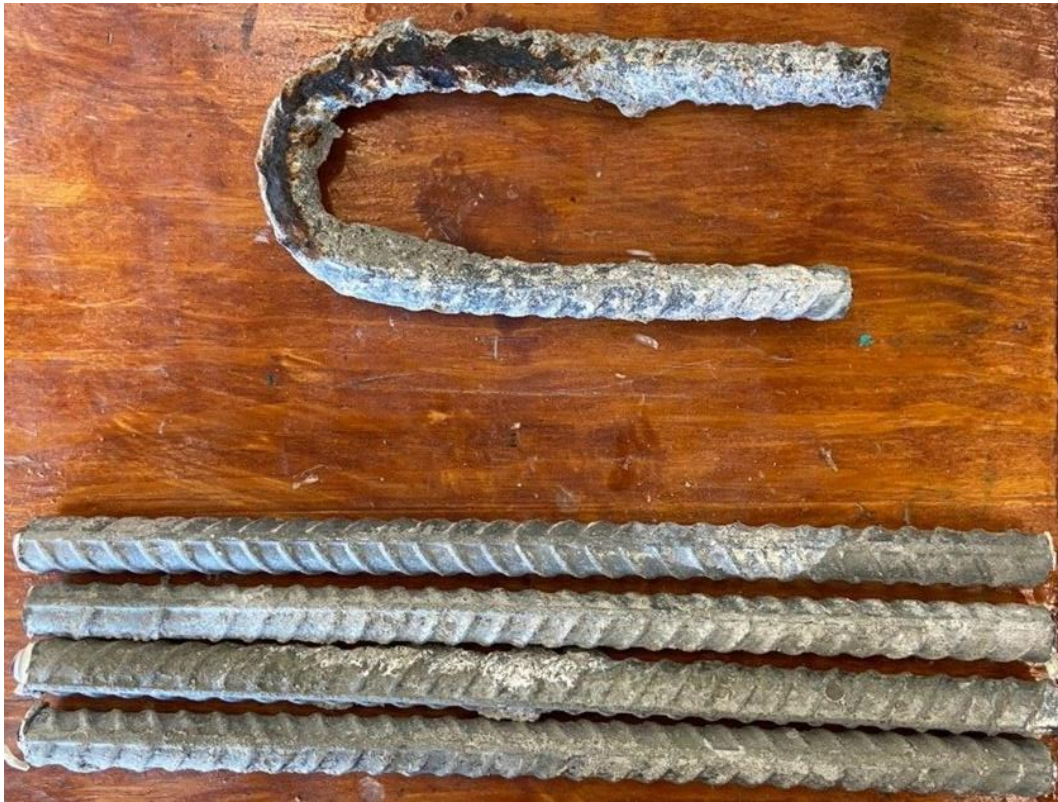
Figures 3.62 and 3.63 show bent A767 and A1094 bars, respectively from the Southern Exposure test. For both types of bar, corrosion products were observed on the top of the bar both at and away from the bend. As discussed based on total corrosion losses, the presence of the bend resulted in a statistically significant increase in corrosion when compared to straight bars.

Figure 3.62: Southern Exposure test. Specimen A767-b-2 after 96 weeks of testing. Top mat (top) and bottom mat (bottom).

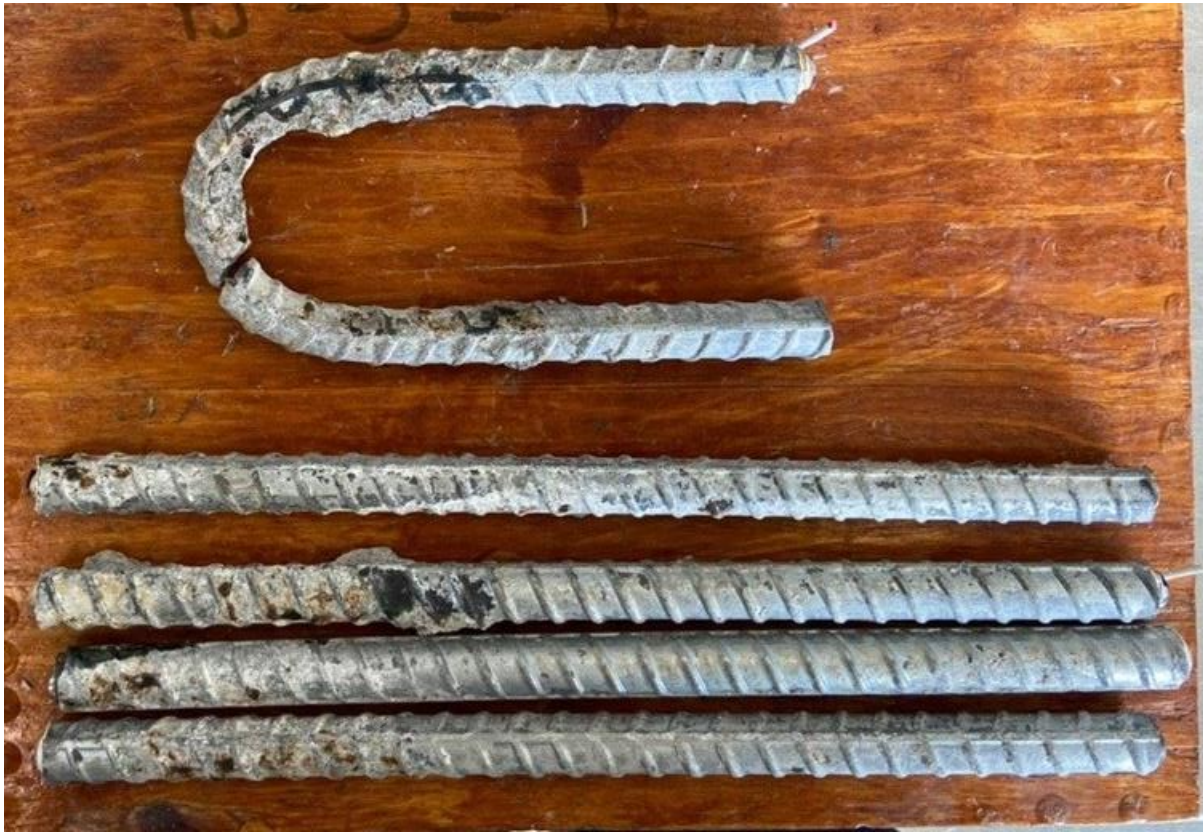
Figure 3.63: Southern Exposure test. Specimen A1094-b-2 after 96 weeks of testing. Top mat (top) and bottom mat (bottom).

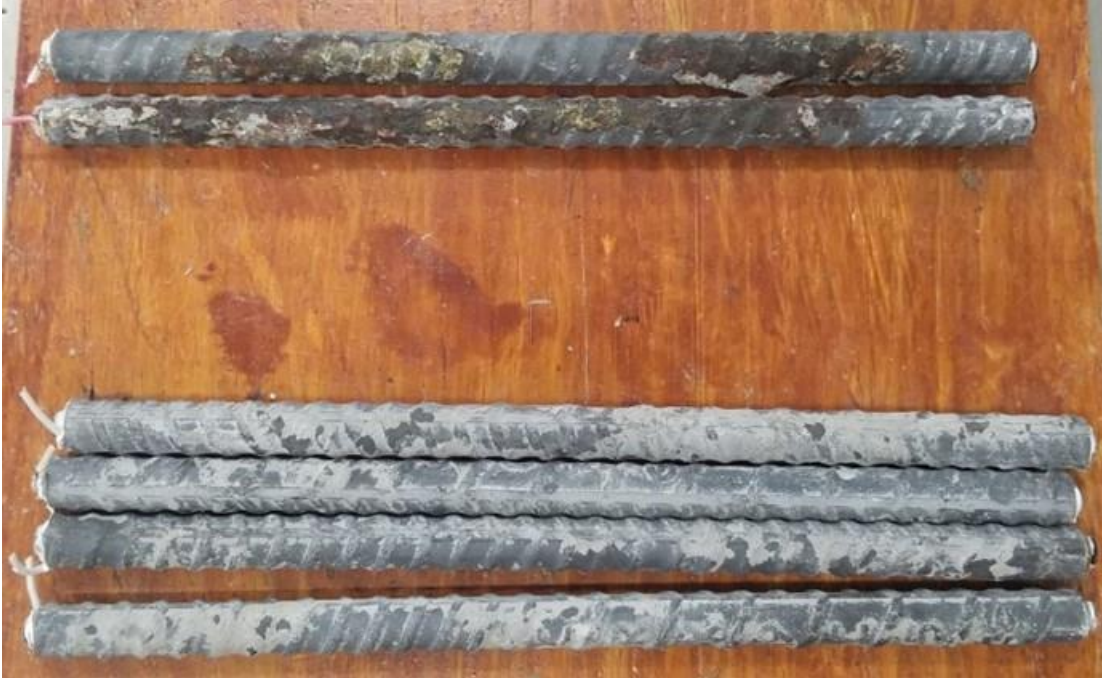
Figure 3.64: Southern Exposure test. Specimen A1035-5 after 96 weeks of testing. Top mat (top) and bottom mat (bottom).

Figure 3.64 shows the bars from Southern Exposure specimen A1035-5 after 96 weeks of testing. Light to moderate amounts of corrosion are visible on portions of both bars from the top mat of steel. No corrosion products were visible on the bars from the bottom mat of steel. A1035 bars in concrete with Ipanex (Figure 3.65) and Xypex (Figure 3.66) did appear to have less corrosion than A1035 with no admixture. Given that overall losses were similar between A1035 specimens with and without Ipanex or Xypex, it is possible the reduced permeability of the concrete resulted in more localized corrosion on the bars.

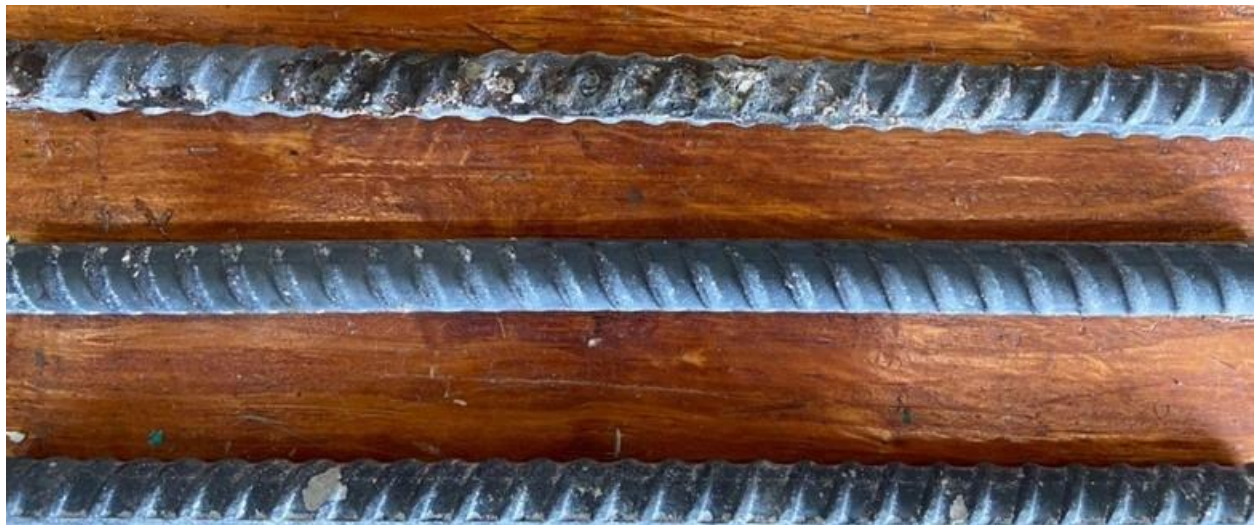
Figure 3.67: Cracked beam test. Specimen A1035-1 after 96 weeks of testing. Top mat (top) and bottom mat (bottom).

Figure 3.67 shows the bars from cracked beam specimen A1035-1 after 96 weeks of testing. Light to moderate amounts of corrosion are visible on both bars from the top mat of steel, significantly less than observed on conventional reinforcement in the cracked beam test. Corrosion was concentrated in the region immediately under the 6-in. simulated crack in the specimen. A1035 bars in concrete with Ipanex (Figure 3.68) and Xypex (Figure 3.69) exhibited similar behavior, with the corrosion products predominantly in the region under the simulated crack.

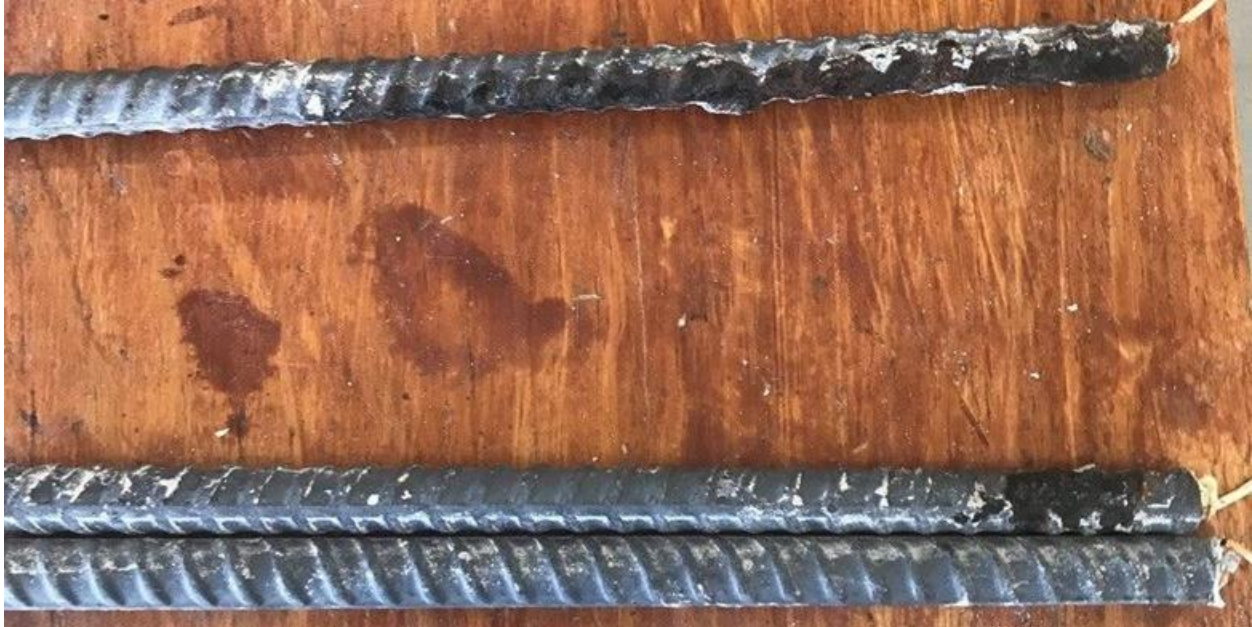
Figure 3.68: Cracked beam test. Specimen A1035-Ipanex-6 after 96 weeks of testing. Top mat (top) and bottom mat (bottom).

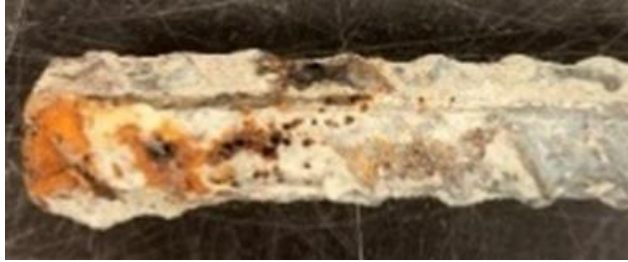
Figure 3.84: Conventional reinforcement from Cow Creek deck panel. Core taken at a crack location.

As described in Section 3.4.7, several cores were taken directly over reinforcement, allowing for an inspection of the reinforcement to be performed. Figures 3.84 and 3.85 show conventional reinforcement obtained from cores taken in cracked and uncracked concrete, respectively. At cracks, conventional reinforcement showed clear signs of corrosion, whereas reinforcement in uncracked concrete was free of corrosion products. These results show that the conventional reinforcement performed well in uncracked concrete, while the inevitable formation of cracks resulted in corrosion, even with the silane treatment. Similar trends were observed for ECR (Figures 3.86 and 3.87), though it should be noted that the extent of corrosion on the ECR was much less than that observed on the conventional reinforcement. Under any circumstances, the presence of cracks in the decks had a deleterious effect on the corrosion performance of both uncoated and epoxy-coated reinforcement and demonstrated in large-scale field studies (Darwin et al. 2011).
